**Summit Park Condominiums Capital Reserve Study**  
Analysis Date – March 1, 2013

## Reserve Asset Photographic Inventory

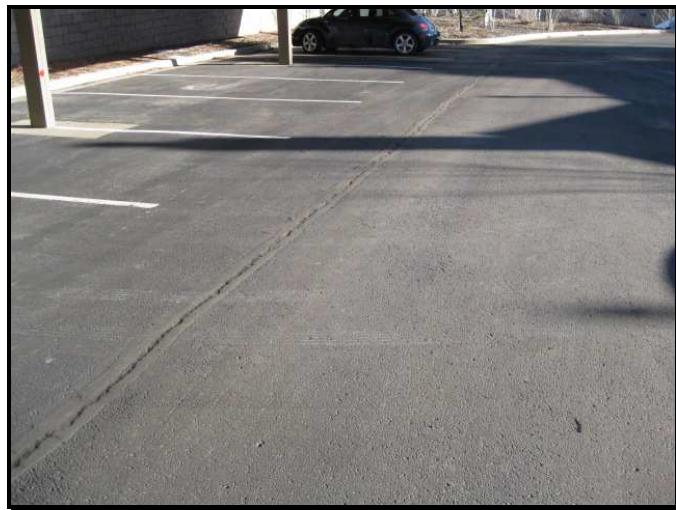
### **Parking Lot Asphalt - Resurface**

This asphalt parking lot was installed between 1996-2000, we are using 1998 as the average install date. Minor cracks and wear noted. The association has an aggressive maintenance program which helps preserve and prolong the life of this asphalt. The useful life of the asphalt has been adjusted to reflect the association's preventative maintenance plan.

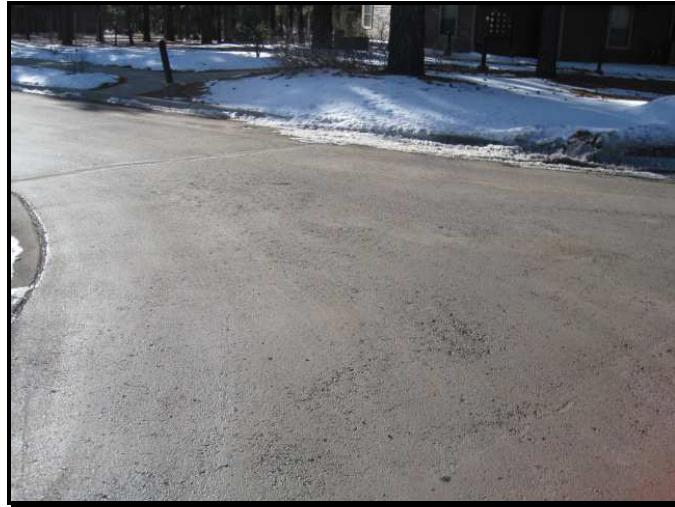
### Parking Lot Asphalt – Seal/Repair

This asphalt is seal coated every 3-years. Surfaces observed to be smooth and in good condition. Recommend maintaining current seal coat cycles to prolong and preserve the asphalt surfaces.

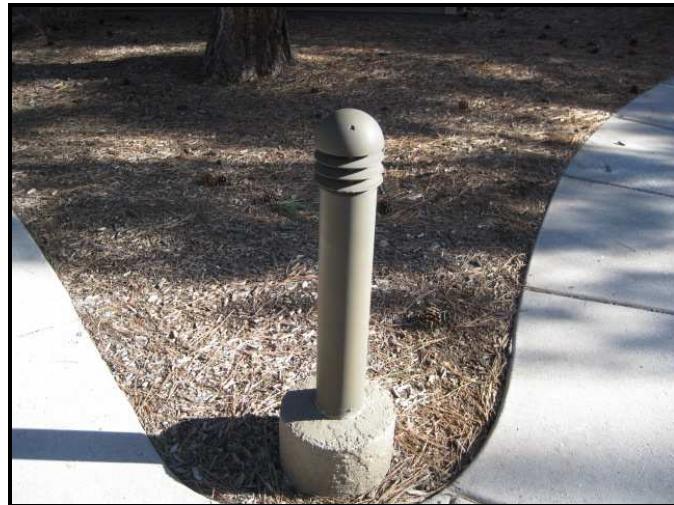
### **Bollard Lights - Replace**

These bollard lights were installed between 1996-2000. We are using 1998 as the average installation date. These lights are located along the walkways throughout the property. Some fixtures were observed to be loose, however, overall good conditions noted. This component budgets for a complete replacement of ALL of the lights at the same time to maintain a uniform appearance throughout the community.

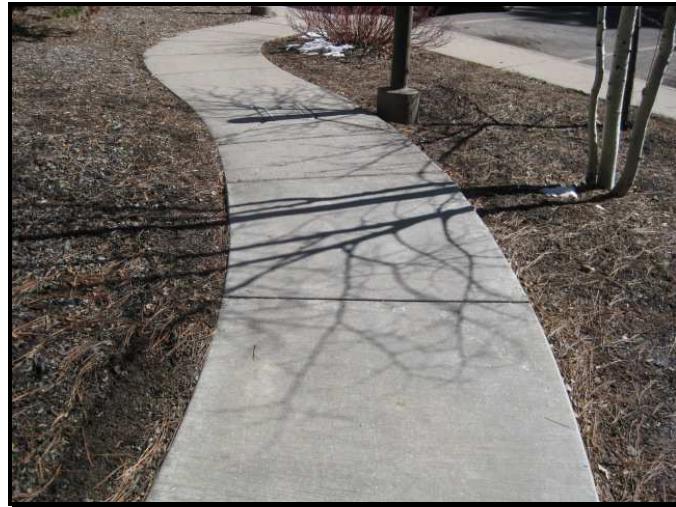
### **Concrete Paths - Replace**

Due to construction defects, the association has been replacing sections of the concrete walkways. The association plans to spend approximately \$6,600 on concrete repairs during 2016. These are one-time expenses planned for 2016 and 2020 (Approximately \$7,427 planned for 2020). There is no expectancy to replace such large quantities of the walkways in the future.

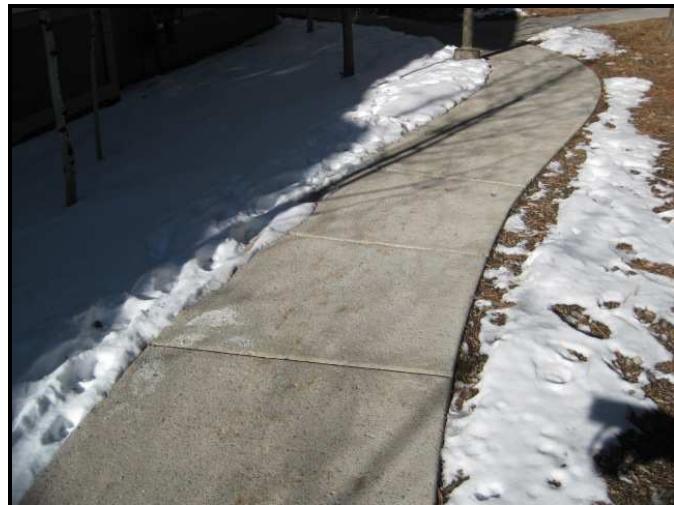
### **Concrete Walkways - Repair**

This component provides an allowance for small repairs and replacements to the concrete walkways throughout the community. The remaining life has been adjusted, so this expense starts 5-years after the 2020 concrete replacement expense (Per client's internal Reserve Study) Concrete is typically a long life component and there is no expectancy to completely replace the concrete.

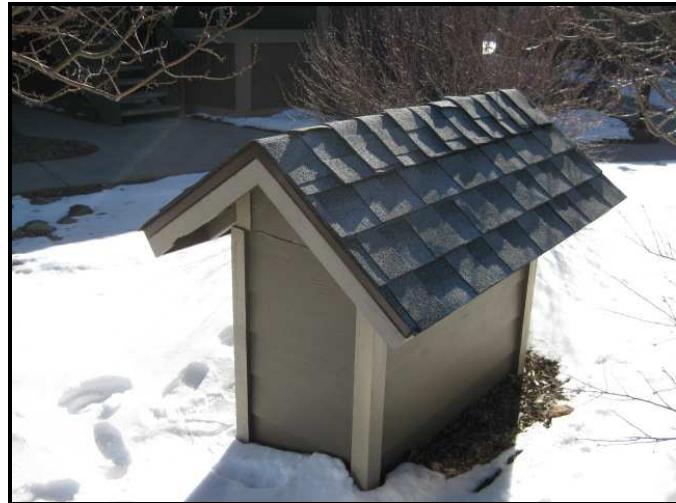
### Backflow Preventers - Replace

There are (2) Febco Backflow Preventers at this property. These are typically a long life component under normal circumstances; however, future replacement should be expected. Inspections and repairs should be handled out of the Operating budget.

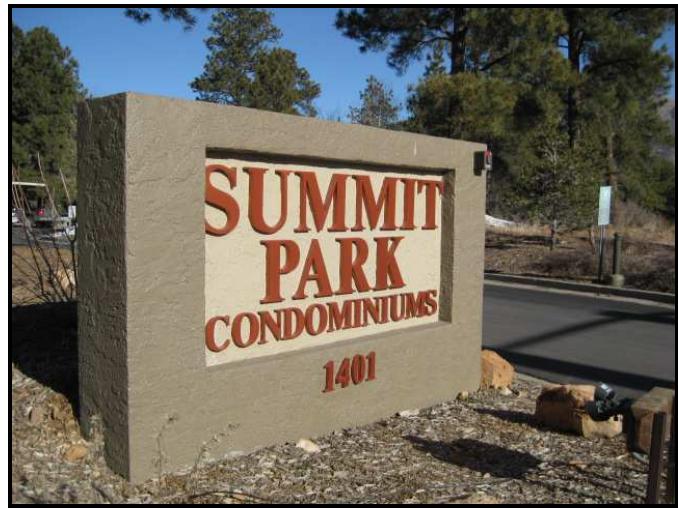
### Monument - Replace

Installed during 2011. This monument consists of 12" and 6" plastic letters mounted to a stucco wall. Letters are intact and in good condition. This component budgets to eventually replace the lettering.

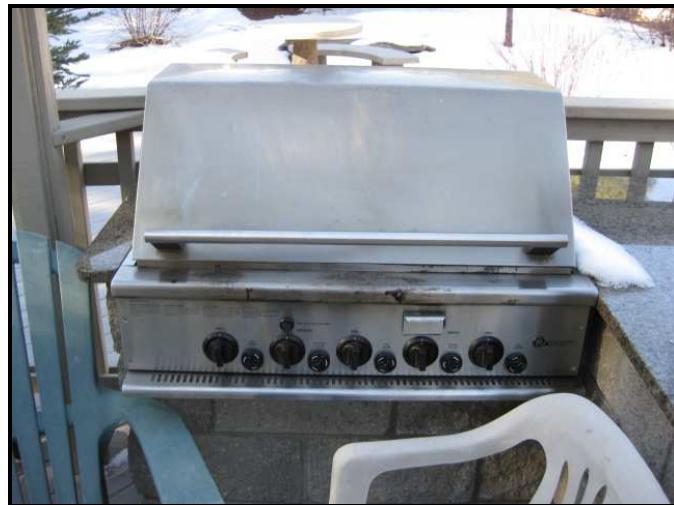
### **BBQ Grills - Replace**

There are (2) BBQ grills located in the common areas. We are assuming a 2005 install date. BBQ still observed to be in decent condition and no reported problems.

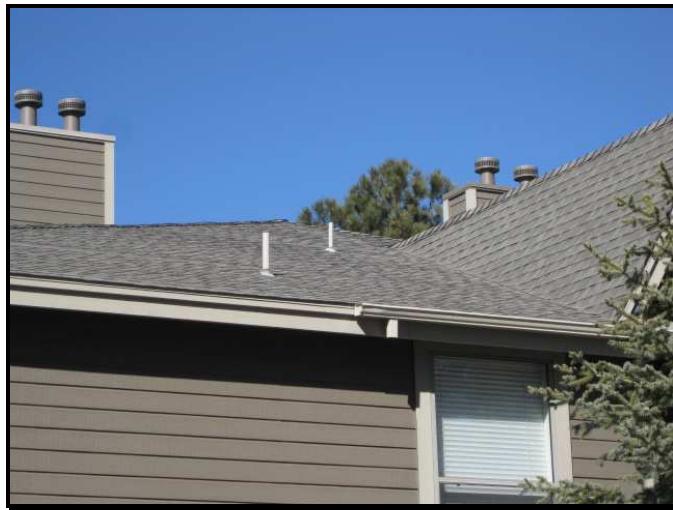
### **Building Roofs – Replace (Ph. 1 – Bldgs. 1-3)**

This line item budgets to replace the shingle roofs at buildings 1, 2 and 3. It was reported that these buildings were built during 1996-1997. We are using 1997 as the installation date for budgeting purposes.

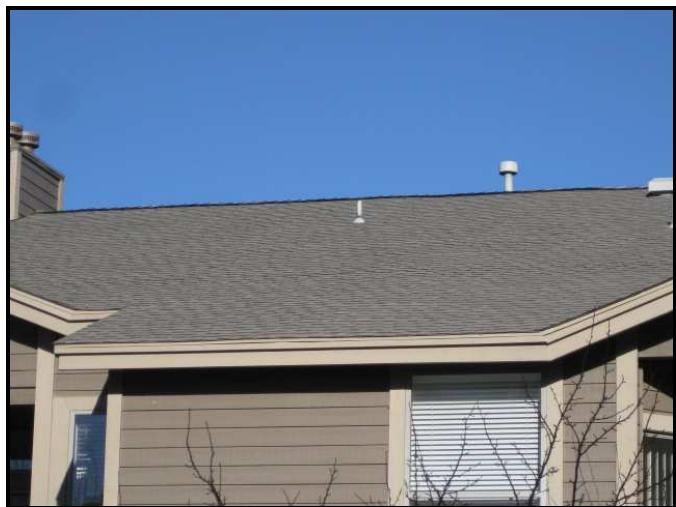
### **Building Roofs – Replace (Ph. 2 – Bldgs. 4-11)**

This line item budgets to replace the shingle roofs at buildings 4-11. These buildings were installed between 1998-2001, we are using 1999 as the average installation date for budgeting purposes.

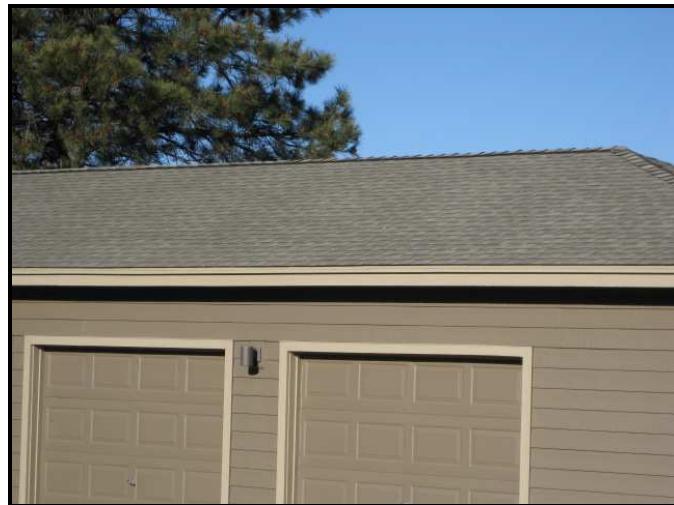
### **Garage/Waste Building Roofs - Replace**

This line item budgets to replace the shingle roofs at the garage and waste buildings. These buildings were installed between 1998-2001. We are using 1999 as the average installation date for budgeting purposes.

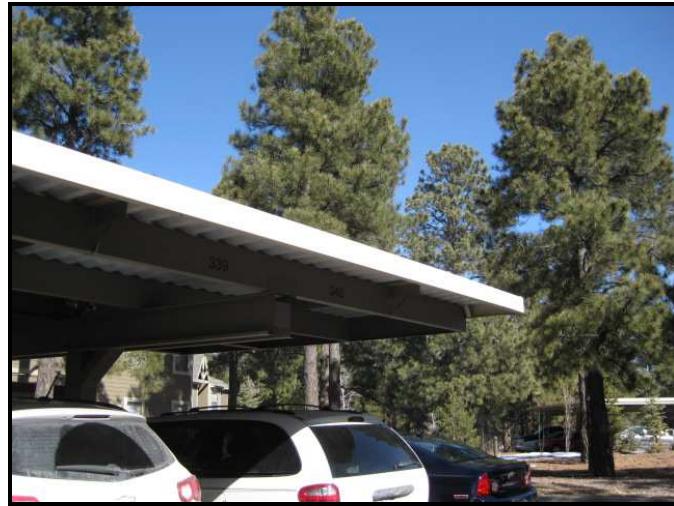
### **Carports – Repair (Allowance)**

This component budgets to repair approximately 5% of the 21,890 Sq. Ft. of metal carport structures.

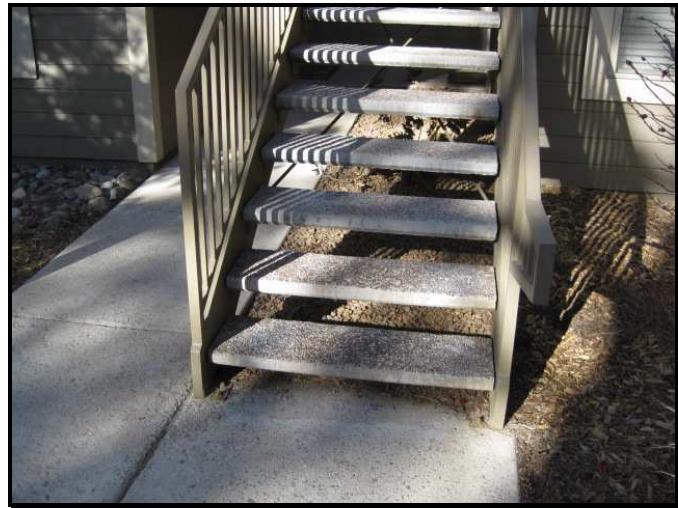
### Stair Treads – Replace/Repair

There are 31 stairways with concrete steps, over time the steps will crack and need repair or replacement. This component provides an allowance for partial repairs/replacements on a 5-year cycle.

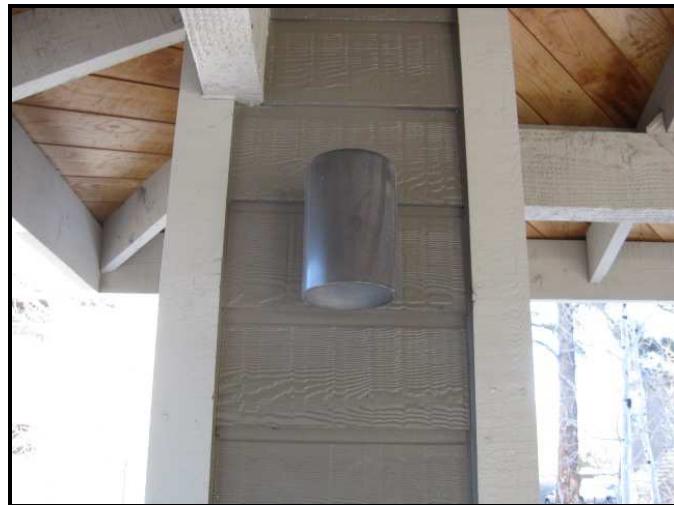
### **Building Wall Lights - Replace**

This line item budgets to replace all of the wall lights mounted to the buildings, garage buildings and common area gazebos. Replacement should be scheduled at the same time to maintain uniformity throughout the community.

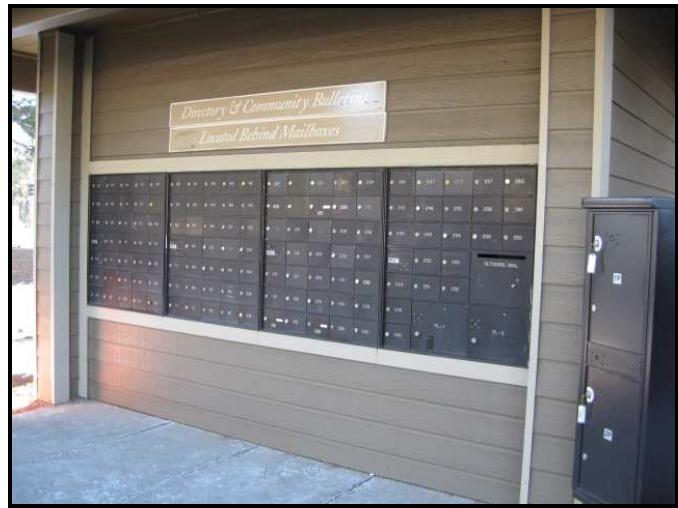
### **Mailboxes - Replace**

These mailboxes were installed between 1996-2001. Using 1998 as average installation date for budgeting purposes. Still in good condition. Future replacement should be anticipated.

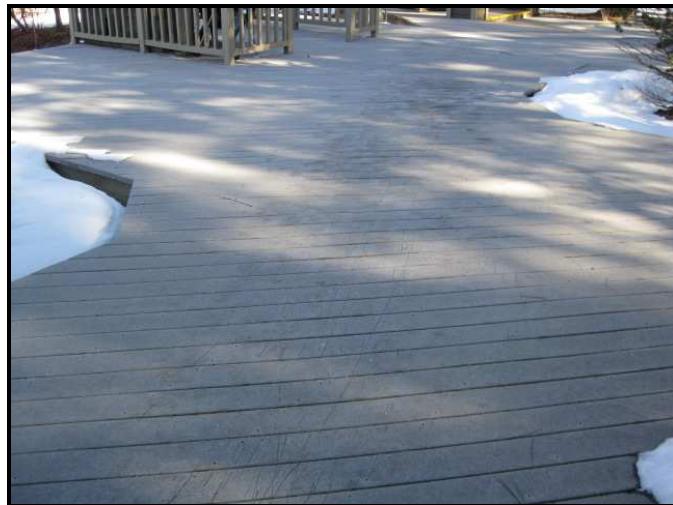
### **Common Area Deck - Replace**

This common area deck is made of composite material. Typically a long life component under normal circumstances, however, future replacement should be anticipated.

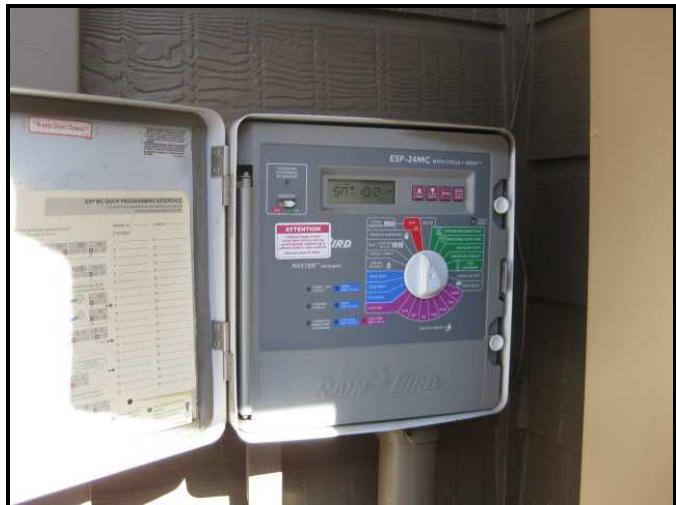
### Irrigation Controllers - Replace

There are (2) ESP-34MC irrigation controllers which control the irrigation system. Installed during 2001. Still functional and in good condition. No reported problems. Future replacement should be anticipated.

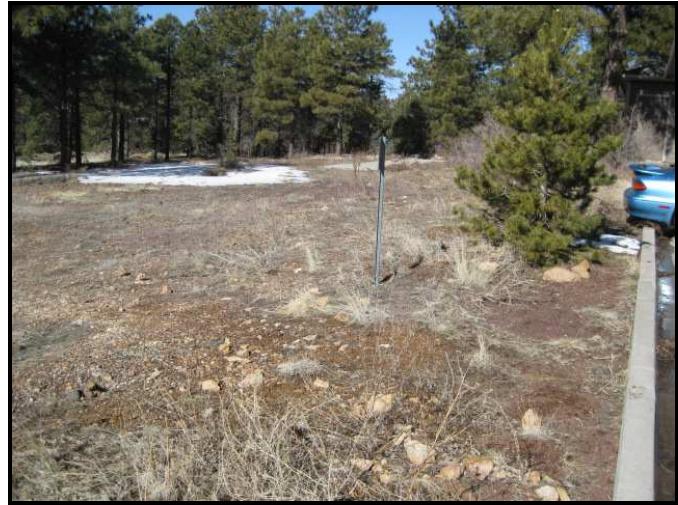
### View Fence - Installation

The association reportedly plans to install a metal view fence here during 2014. This component provides a one-time expense during 2014 to install the metal view fence. **This report will need to be updated after 2014, to reflect actual installation costs and quantities.**

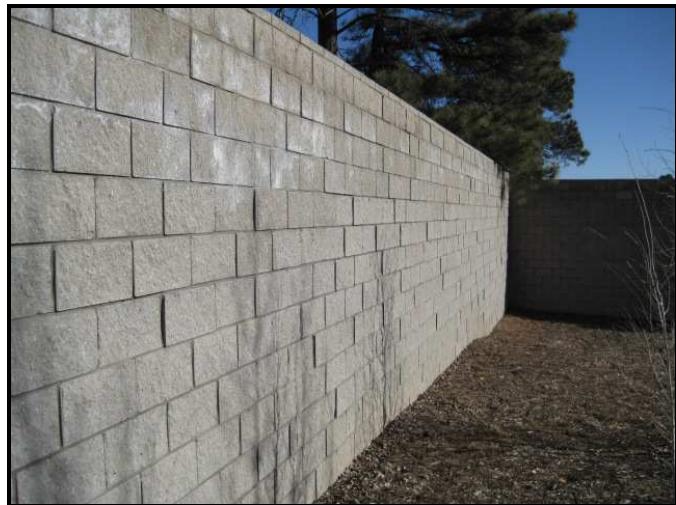
### **Block Walls - Repair**

Installed between 1996-2001. Walls are expected to last the life of the community under normal circumstances. This component provides an allowance for repairs and/or partial replacement due to excessive settling or other sources of damage.

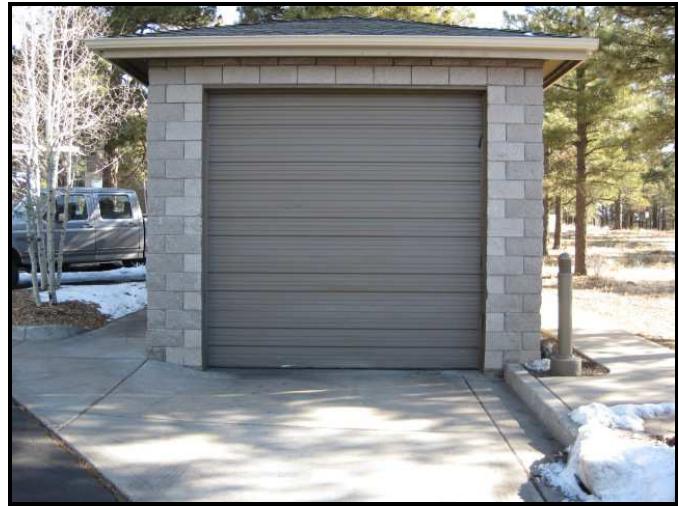
### **Roll-up Doors – Replace**

Installed between 1996-2001, using 1998 as average installation date. These doors were observed to be in good condition. Doors reportedly receive a lot of abuse, therefore we recommend planning for eventual replacement.

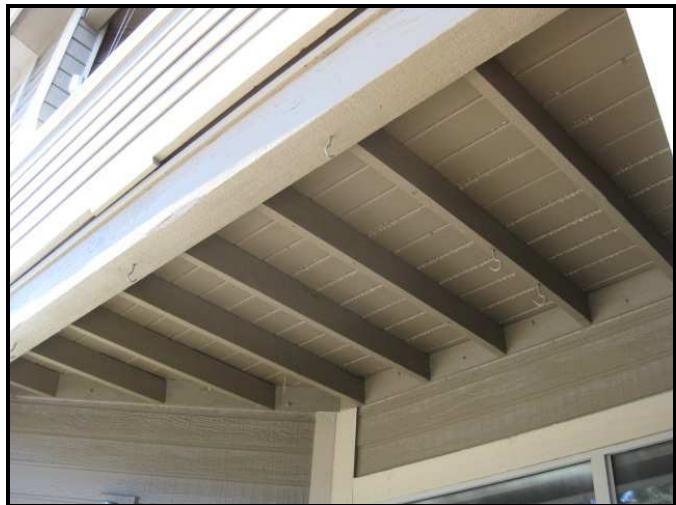
### Balcony Decks – Replace

Installed between 1996-2001 using 1998 as average installation date. Replacement cost is increased due to location and access. No reported issues or problems. Assumed to be in good condition.
