Summit Park Condominiums

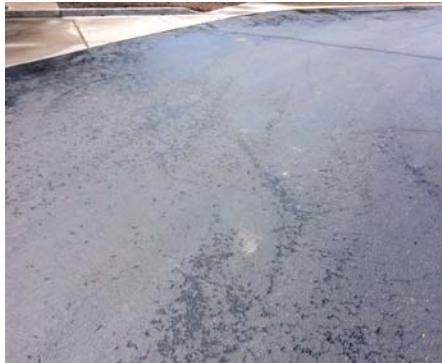
Asphalt - Resurface

The asphalt pavement is original and in fair to poor condition. The useful life of asphalt pavement in Flagstaff is from 20-25 years. Based on the visual condition and current configuration of the asphalt pavement, we recommend a mill and overlay application at roughly the cost and timing listed above.

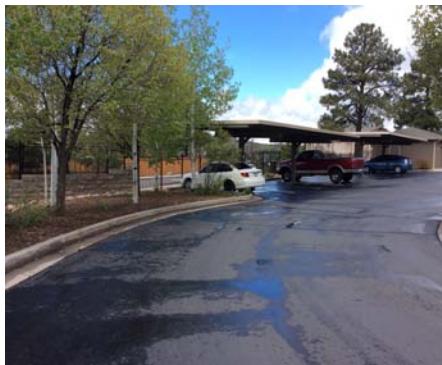
Asphalt - Seal Coat

Preventative maintenance applications include: Regular Seal Coats, Crack Filling and Patching. This line item provides funds to seal and make minor repairs to the asphalt pavement every 3 years.

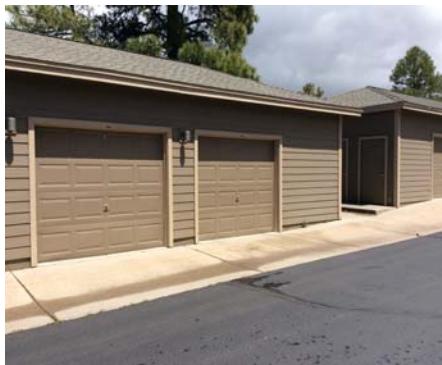
Garage Building Roofs - Replace

Composite shingle roofs have a useful life of 20-25 years. No observed or reported issues. We recommend regular inspections and repairs as-needed with Operating funds.

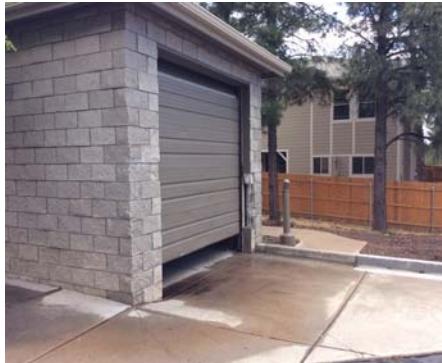
Roll-Up Doors - Replace

There are (3) Metal Roll-up style doors located at each trash building. No signs of damage. Future replacement should be anticipated.

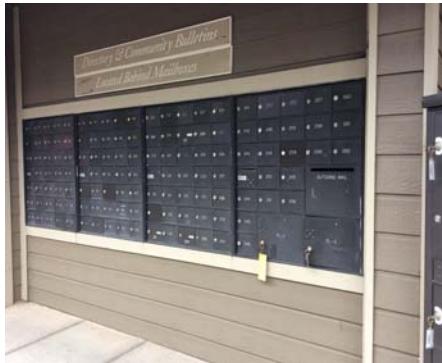
Mailboxes - Replace

These mailboxes are CBU style or Cluster Box Units. Mailboxes have a useful life up to 25 years. Replacement units should meet the standards of the United States Postal Service.

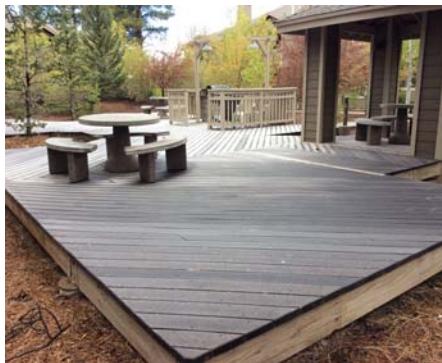
Common Area Deck - Replace

Composite Decking has a useful life of up to 25 years. Moderate signs of age and wear noted, however still intact and in fair condition. Future replacement should be anticipated.

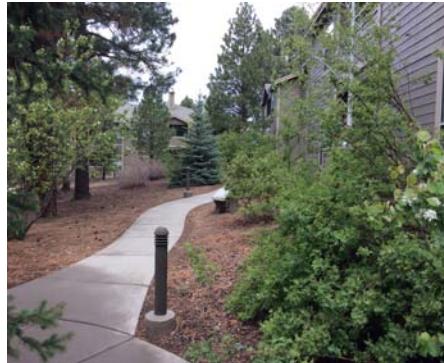
Bollard Lights - Replace

There are approximately (150) bollard lights located throughout the property. Overall fair conditions observed, however some light fixtures are loose and in need of repair. Minor repair should be funded with Operating funds.

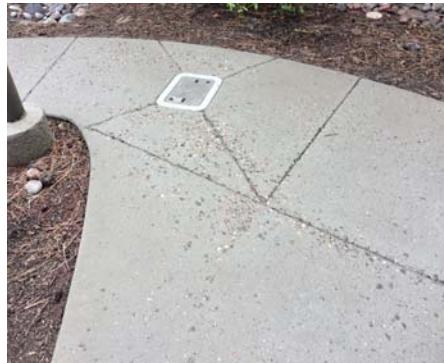
Concrete Walkways - Repair

The association is responsible to maintain the concrete walkways throughout the property. Concrete surfaces have a long useful life, however isolated repairs due to cracking, lifting or spalling are common.

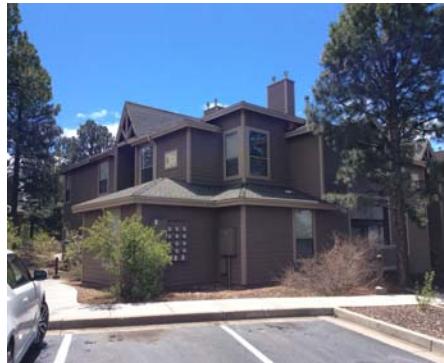
Building Roofs - Replace (Ph. 1)

Composite shingle roofs have a useful life of 20-25 years. No observed or reported issues. We recommend regular inspections and repairs as-needed with Operating funds.

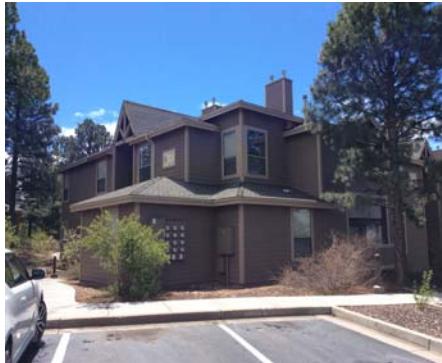
Building Roofs - Replace (Ph. 2)

Composite shingle roofs have a useful life of 20-25 years. No observed or reported issues. We recommend regular inspections and repairs as-needed with Operating funds.

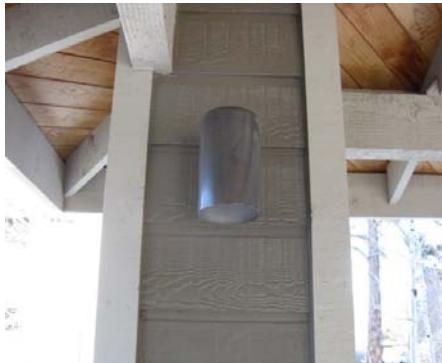
Building Wall Lights - Replace

This line item budgets to replace all of the wall lights at the same time to maintain uniformity throughout the community.

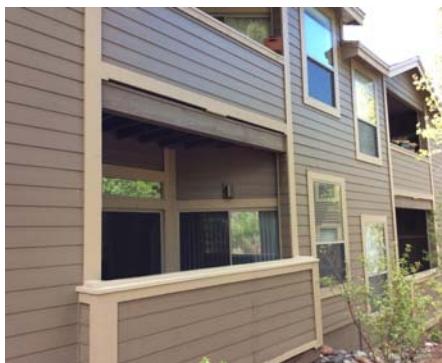
Balcony Decks - Replace

Composite Decking has a useful life of up to 25 years. Future replacement should be anticipated according to the cost and time frame listed above.

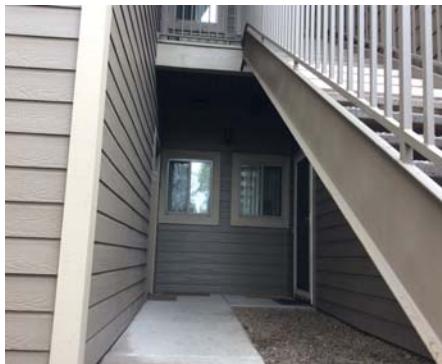
Windows - Partial Replace

Windows have a useful life expectancy up to 50 years, however partial replacements will be necessary before the 50 year useful life. The useful life of windows and doors is based on current technology, water infiltration and thermal inefficiencies. Based on these factors, we recommend establishing an allowance for replacement of 10% of the total windows with a useful life of 30 years.

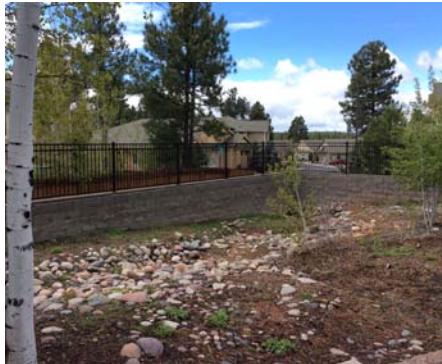
View Fence - Replace (South)

This fence was installed during 2014. Good conditions observed. Future replacement should be anticipated.

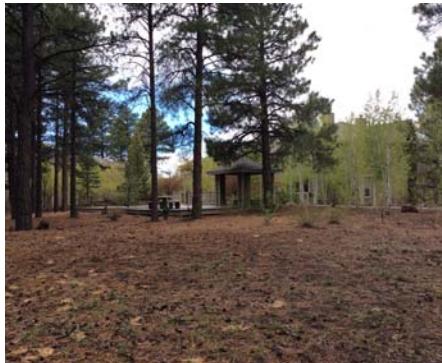
View Fence - Install (North)

The association has plans to install a view fence along the North boundary of the property. This line item provides an estimate to install 150 linear feet of view fence during 2017.

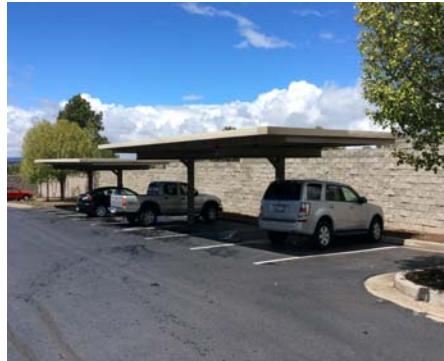
Carport Roofs - Repair (5% of Total)

There is approximately 21,890 square feet of metal carport structures located throughout the parking areas at Summit Park. Metal carports are subject to damage, this line item budgets for periodic repairs at roughly the cost and time frame listed above.

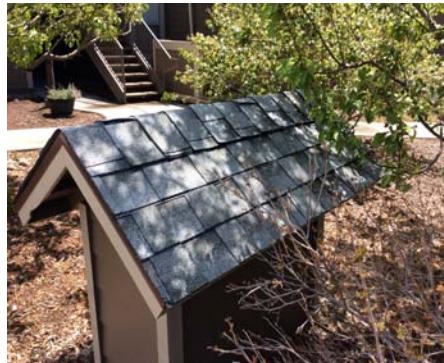
Backflow Preventers - Replace

There are (2) Febco backflow preventer devices at Summit Park. These devices should be inspected and tested annually by qualified contractors. Maintenance and repairs should be handled with Operating Funds. Future replacement should be anticipated.

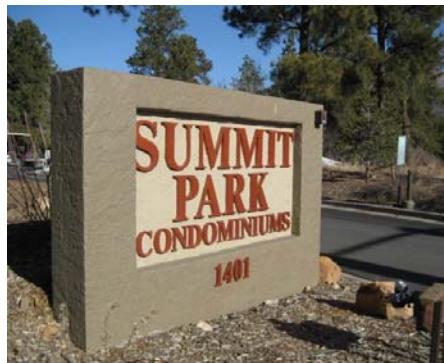
Monument Sign - Refurbish

This monument sign consists of a stucco backdrop with vinyl lettering. Replacement/Refurbishment is typically an aesthetic improvement versus component failure or deterioration.

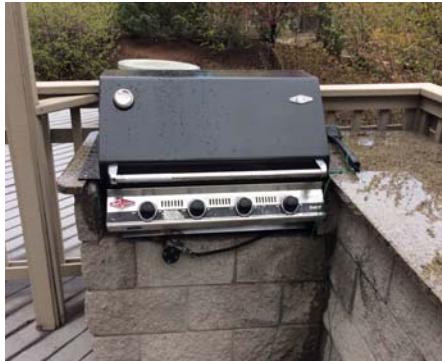
BBQ Grills - Replace

These grills were recently purchased by the HOA, however replacement should be expected in the near future with higher quality, commercial grade grills.

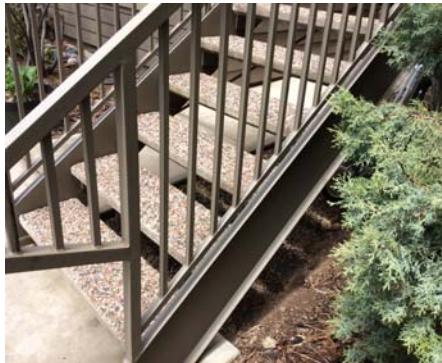
Stairs - Repair (Treads/Railing/Stringers)

This line item provides funding to repair as-needed the building staircases. Typical repairs include: concrete tread replacement, repainting/repairing stair railings, replacement of the staircase beams/stringers and general maintenance activities.

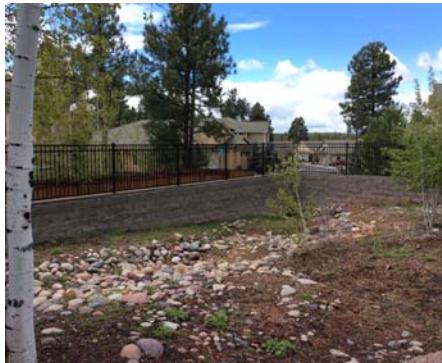
Block Walls - Repair (10% of Total)

Block walls have a long useful life expectancy, however it is prudent to plan for partial replacements or repairs due to settling, vandalism or un-insured damages.
